## LANDSLIDES AND RELATED FEATURES

OF THE FAYETTEVILLE, W. VA. QUADRANGLE

by  
GREGORY C. OHLMACHER

OPEN FILE MAP 83-80 (A-8)

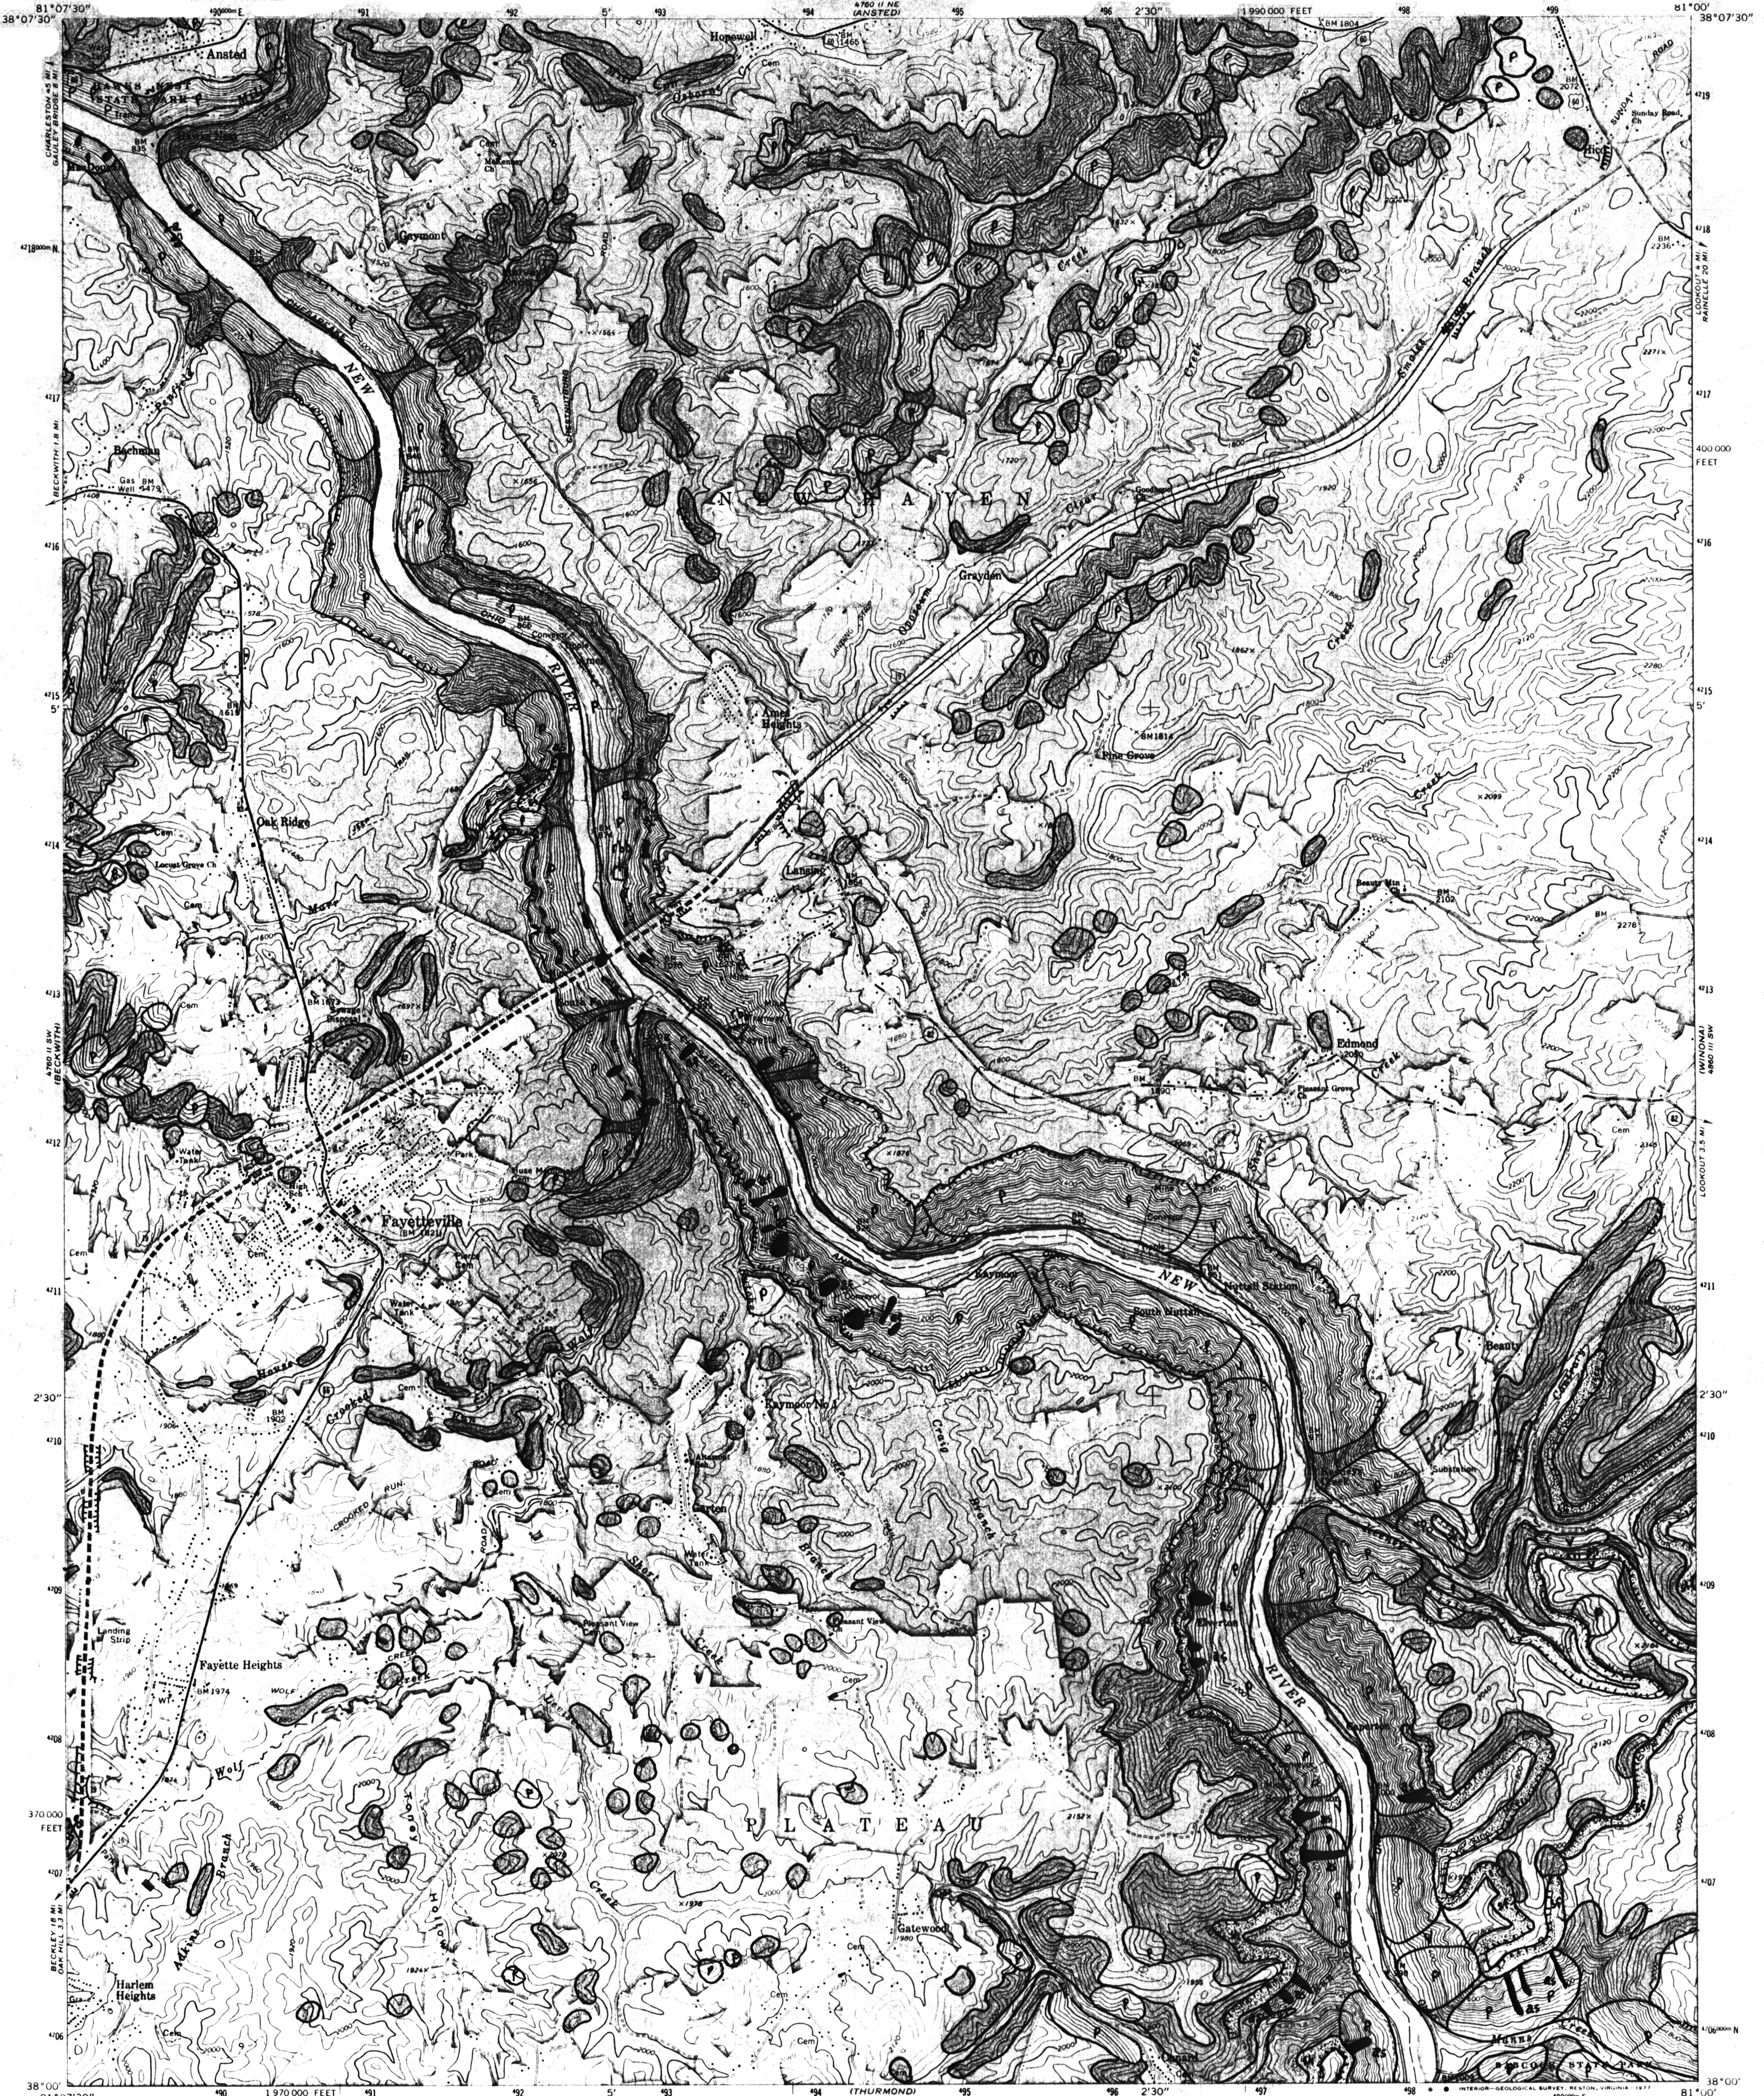
FAYETTEVILLE, W. VA.  
SE/4 FAYETTEVILLE 15' QUADRANGLE  
N3800—W8100/7.5

Landslides and related features interpreted from aerial photographs:  
1:60,000 SCALE BLACK AND WHITE 1960  
1:125,000 SCALE COLOR INFRARED 1973  
1:80,000 SCALE BLACK AND WHITE 1976

Photointerpretation and field check 1979.  
This map has not been edited or reviewed for conformity with Geological Survey standards and nomenclature.

**ACTIVE OR RECENTLY ACTIVE LANDSLIDE**  
Complex landslide composed of earthflow, debris slide, earth and rock slump. Identified from historical records, and from scars, debris and other field evidence. Ground extremely unstable, sliding accelerated by excavation, loading and changes in drainage conditions. May include areas with several active slides too small to be shown separately.

**OLD LANDSLIDE**  
Area of extensive hummocky ground caused by earthflow and earth and rock slump. Lacks clear evidence of active sliding. Relatively stable in natural, undisturbed state, generally not affected by small structures properly sited in areas away from the edge of the toe, can be reactivated by extensive, rapid excavation, loading, and changes in ground water and surface water conditions. Area of old landslide probably includes recent ones not identified from field evidence or otherwise documented. Upslope boundary of landslide generally defined by modified scarp, but downslope (toe) may be gradational and not well defined.

**COLLUVIAL SLOPE**  
Valley wall along major streams with slope as steep as 40° (85%). Stony, clayey silt soil up to 50 ft. (15 m) thick, commonly buttressed by a terrace or bench at the toe of the slope, very susceptible to sliding by cutting of toe area, removal of terrace or bench, and overloading, slide commonly activated without apparent cause.

**AREAS SUSCEPTIBLE TO DEBRIS FLOWS AND DEBRIS AVALANCHES**  
Primarily shallow, narrow ravines and chutes with accumulation of stony colluvium generally 10 ft. (3 m) or less in thickness, susceptible to rapid movement during intense rainfall. Most ravines and chutes designated show evidence of former debris flows and avalanches. Symbols 'a' designates historical debris flow or debris avalanche.

**AREAS SUSCEPTIBLE TO ROCKFALL**  
Steep, locally vertical, natural and man-made slopes and cliffs, 15 ft. (4.5 m) or more high, formed dominantly of sandstone, limestone, sandy shale, mudstone and claystone. Interbedded mudstone, claystone and shale weather rapidly leaving sandstone and limestone rock faces unsupported.

**SOIL AND ROCK SUSCEPTIBLE TO LANDSLIDING**  
Soil and rock similar to that involved in landslides elsewhere in map area; primarily areas underlain by claystone, mudstone and shale associated with other rock types. Rock weathers rapidly on exposure forming clayey soil highly susceptible to sliding. Includes coves (U-shaped, shallow valleys) containing thick layers of clayey soil that are very susceptible to sliding where excavation breaks continuity of slope and where overloaded by artificial fill.
